Report No. 79-2

Demonstration of  
**MARSH TURBO THRUSH**  
to Deliver Pesticides  
to Coniferous Forests

DECEMBER 1978

DEMONSTRATION OF THE MARSH TURBO THRUSH  
TO DELIVER PESTICIDES TO CONIFEROUS FORESTS  
Phase 2 - Forest Spraying

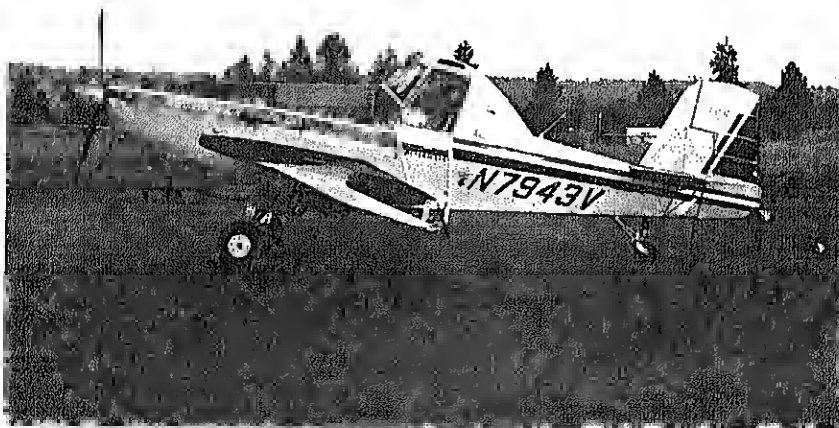
Figure 1. Marsh Turbo Thrush. Note 400-gallon hopper forward of cockpit. Turbo Thrush test, Idaho 1978.

The Marsh Turbo Thrush is the Rockwell Thrush Commander agricultural spray aircraft converted to jet prop. Marsh Aviation of Mesa, Arizona, performs the conversion and markets the aircraft (Figs. 1 and 2).

One Marsh Turbo Thrush owned by Mountain Air Spray Company, Craig, Colorado. This fixed-wing jet-prop powered (Garrett TPE-331) spray aircraft was the primary test vehicle (Fig. 1).

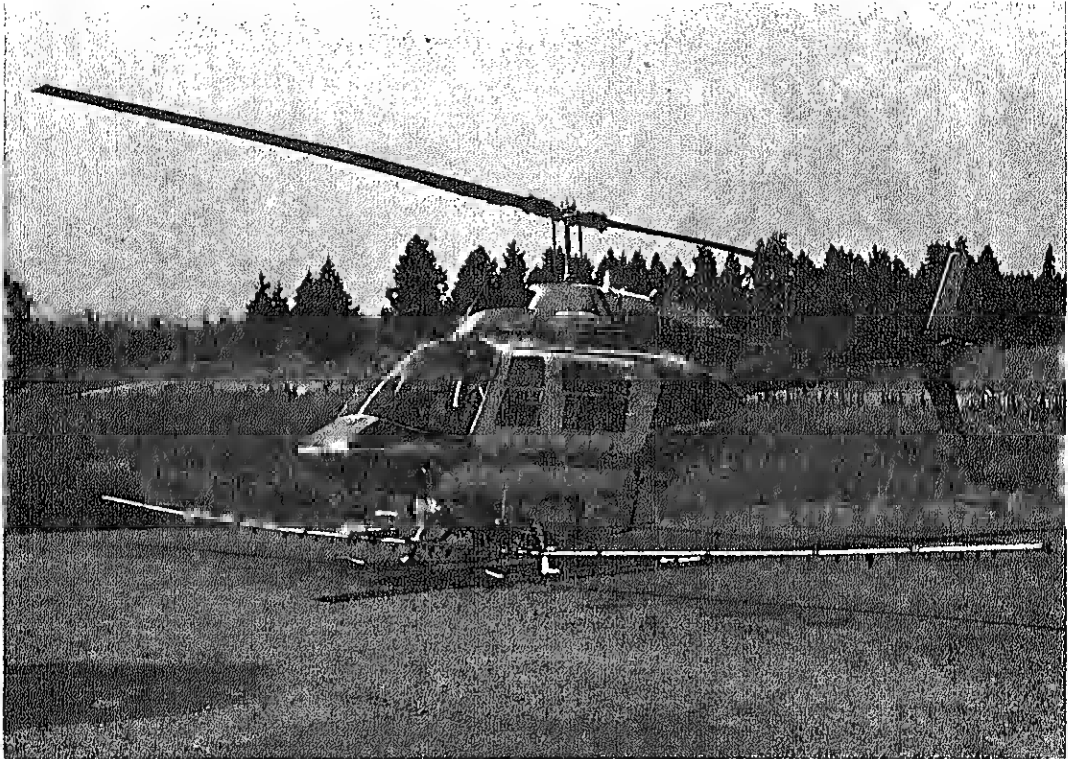
Figure 3. Bell 206B Jet Ranger helicopter with spray system. Turbo Thrush test, Idaho 1978.

We were unsuccessful in locating a helicopter capable of flying 90 mph. We were able to locate a Bell Jet Ranger (Fig. 3), capable of spray speeds of about 70 mph. Faced with the option of conducting the demonstration without a helicopter for comparison, we used the Jet Ranger.

One Bell 206B Jet Ranger owned by Cascade Helicopters, Cashmere, Washington. This was the primary spray helicopter equipped with Simplex spray system - external tank and booms (Fig. 3).

Both aircraft were calibrated at the McCall airport to deliver the one-half gallon per acre. The Jet Ranger (Figs. 3, 7, 8) was calibrated by capturing spray from a nozzle on each end of the spray boom and comparing the captured volume to time. The Turbo Thrush, with a propeller-driven Root pump system (Fig. 9), was calibrated by measuring the volume required to refill the hopper to its original level after one minute of airborne spraying. New Spraying Systems Company nozzles, screens, and tips were used on both aircraft. The Turbo Thrush was equipped with 18 TeeJet Flat Fan 8015 nozzle tips and the Jet Ranger with 28 Flat Fan 8003 tips. In an attempt to achieve a smaller drop size with the Jet

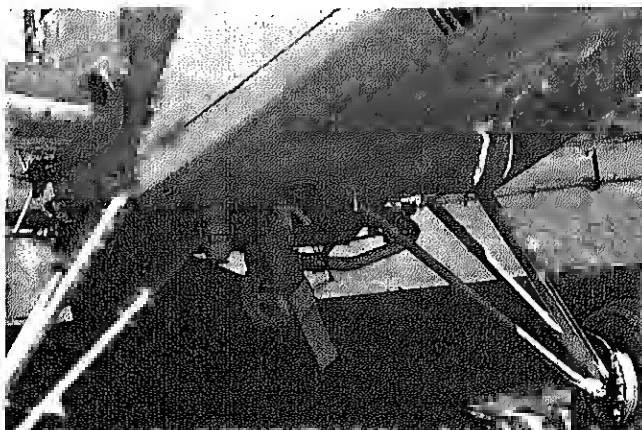
Figure 9. Wind-driven pump mounted on Turbo Thrush. Turbo Thrush test, Idaho 1978.

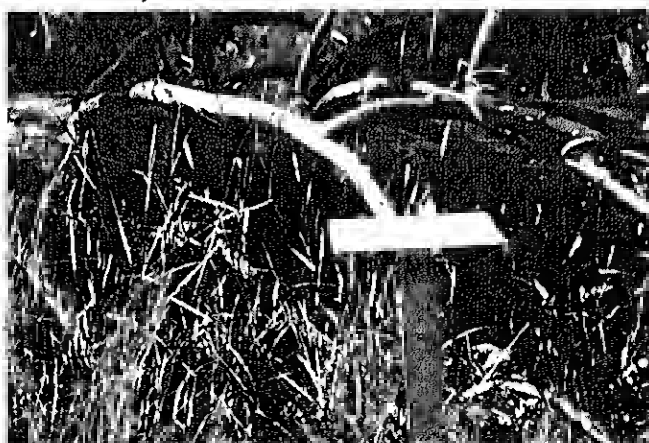
Figure 13. Kromekote card in holder at stake position A-1. A is sampling A and 1 is the first sampler in line A. Turbo Thrush test, Idaho 1978.

Four spray deposit card lines were established in each block (Fig. 6). Lines were 933 feet apart and perpendicular to the expected flight path. A sample site (Fig. 13) was selected every 75 feet along each card line unless the point fell on or within one foot of a tree trunk,

in which case the site was moved a foot or two in any direction. Clinometers were used for slope compensation so the distance between sample sites was a horizontal distance, not a slope distance. At each sample site a 1 x 2-inch wooden stake, three feet high, was used to hold a deposit card sampler. The card line number and sample number were marked on each stake. Standard Kromekote spray deposit cards were positioned just before spray application (Fig. 13).
